Manhole Inspection Summary

Manhole # S39C2_013MH

Insp Date: **12/11/07 9:15 AM**

Location Address: **4008 Orchard**

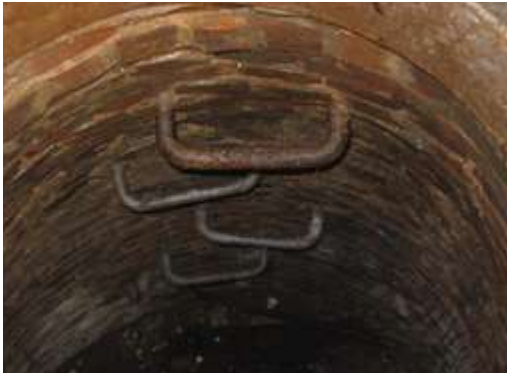
Steps Count: **4** Missing: **0** ☒ **Corroded**

steps

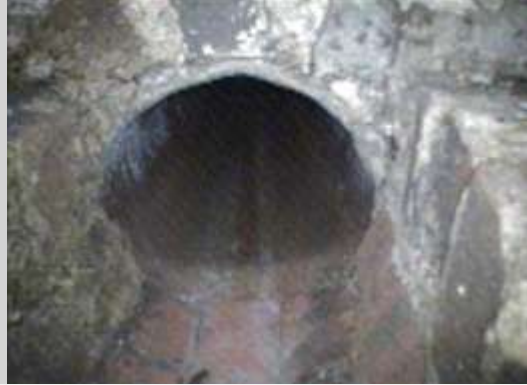
12 O'Clock Outflow

8 in. Circular Gravity Sewer
Pipe Out @ 12 O'Clock

Pipe Height: **10.8** (in.) Rod and Bar (Angled)
Pipe Material: **Clay** ☐ Pipe Lined
Invert Depth: **9.84** (ft.) Flow Characteristics: **Slow**
Deposits: ☒ None ☐ Mud ☐ Sludge ☐ Debris ☐ Grease
Silt Depth: (in.) Deposits Extent:
Infiltration: **None** Pipe Seal Cond: **Sound**

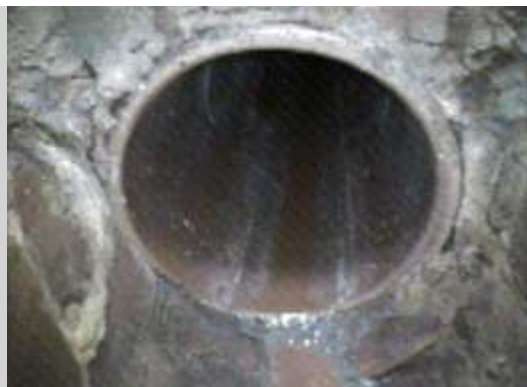
6 O'Clock Inflow

8 in. Circular Gravity Sewer
Pipe In @ 6 O'Clock

Pipe Height: **10.8** (in.) Rod and Bar (Angled)
Pipe Material: **Clay** ☐ Pipe Lined
Invert Depth: **9.40** (ft.) Flow Characteristics: **Slow**
Deposits: ☒ None ☐ Mud ☐ Sludge ☐ Debris ☐ Grease
Silt Depth: (in.) Deposits Extent:
Infiltration: **None** Pipe Seal Cond: **Sound**
